**KOMITE NASIONAL KESELAMATAN TRANSPORTASI
REPUBLIC OF INDONESIA**

KNKT.18.10.35.04

Aircraft Accident Investigation Report

**PT. Lion Mentari Airlines
Boeing 737-8 (MAX); PK-LQP
Tanjung Karawang, West Java
Republic of Indonesia
29 October 2018**

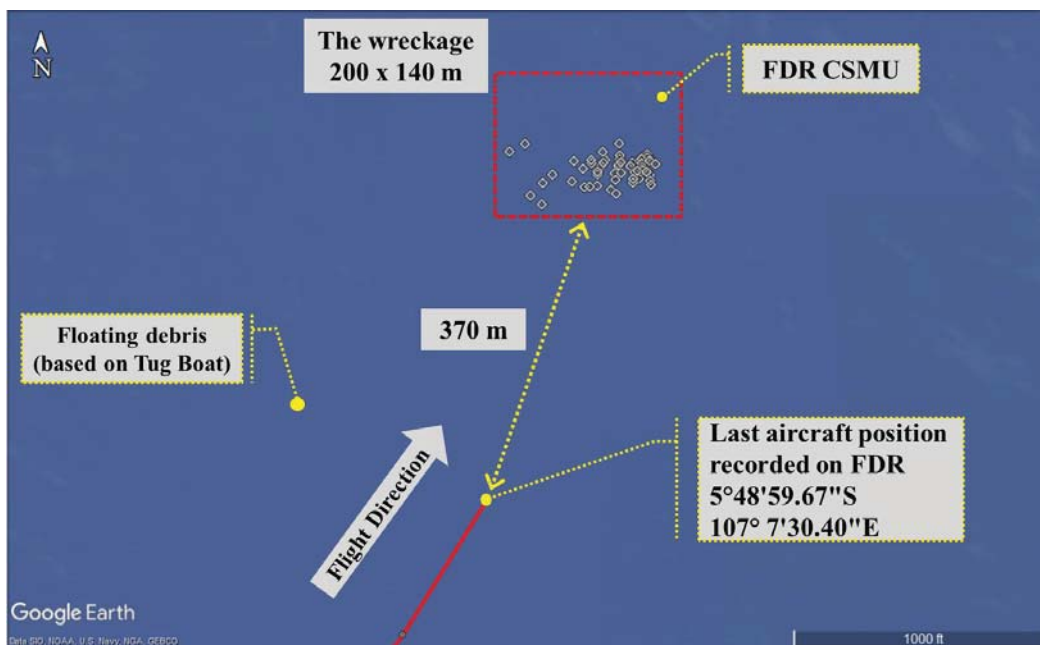
Figure 8: The wreckage distribution

The damage to the aircraft suggested a high energy impact.
